## Case Studies of UV-KLEEN using ATP Luminometer

### Case Study 1: Commercial Office building with workstations.

## Case Study 2: Single-family house

### Case Study 3: Restaurant

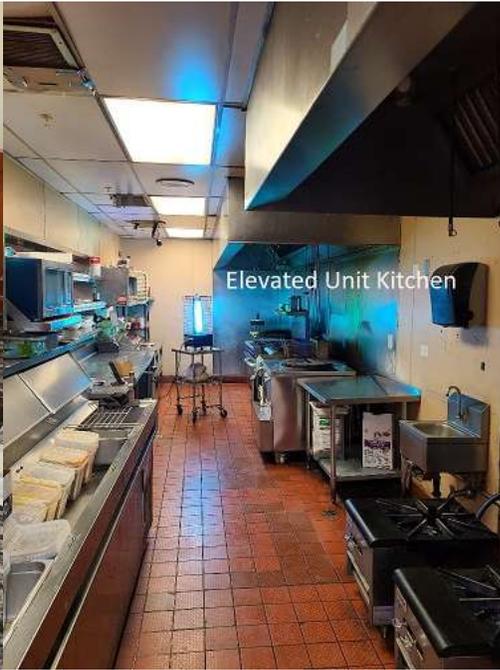
Elevated Unit Kitchen

Note: The griddle height was approximately 32 inches from the ground. Due to the size and shape of the kitchen area, the PRK's UV light was never shining on the griddle surface. At the time of testing, the air circulation of the restaurant was extremely limited, causing the Ozone to settle on the ground, and never spread across the griddle. After 5 minutes of testing, the PRK was lifted high to the level of Griddle for better disinfection rates. Appendix C shows the picture of elevated PRK in the kitchen.
